Korenix JetNet Industrial Managed Switch JetNet 4510 SOFTWARE RELEASE Notes

About This Software Version

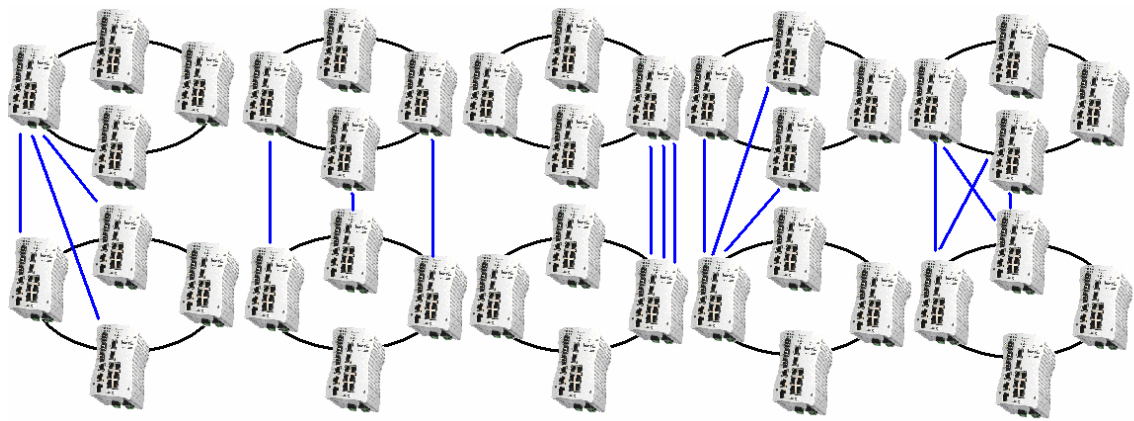
- The querier can't auto election when DUT connect with Cisco Switch. (# 1110)
- Super Ring v2 can't run with LLDP function. (#1142)
- As the ring topology as below, link down /up active ring path will cause the ring status show "Abnormal" when this architecture working with JetView Pro for 2 days, also one of DUT will not be discovery by JetView Pro utility (# 1143,1144)
