VersaMax Micro PLC Backup Battery

IMPORTANT PRODUCT INFORMATION

Introduction

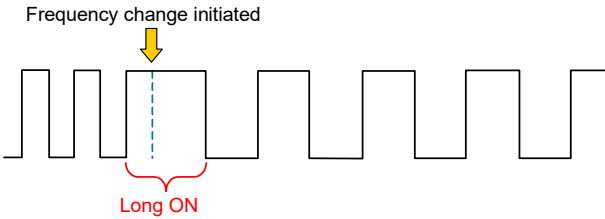
Output Waveform During PWM Frequency Change	During PWM frequency change, a Long OFF or Long ON may occur at the first pulse of the new frequency. Examples are illustrated below.
Long OFF	<p style="text-align: center;">Frequency change initiated</p>

<p style="text-align: center;">Long OFF</p> <p>If the transition occurs while the pulse is OFF, the maximum time the output is OFF is equal to the old frequency OFF state duration plus the new frequency pulse duration.</p>

Issue	Description
<p>Long ON</p>

<p>If the transition occurs while the pulse is ON, the maximum time for which the output is ON is equal to the old frequency ON state duration plus the new frequency pulse duration. (Micro 20/40/64).</p>
<p>Compatibility with old Machine Edition (below version 6.0), and new firmware (3.83 or later) for Ethernet throughput enhancement</p>	<p>. Old Machine Edition allows data rates 300 through 38400 bps for the Ethernet option module on Port2. But the new firmware supports only 19200, 38400, and 175000 bps. When any data rate lower than 19200 bps is configured, communication with the Ethernet Option module is not guaranteed.</p>
<p>The RS-232/USB module is auto-configured as an Ethernet Option module with SNP protocol and 175Kbps data rate.</p>	<p>Auto-configuration with these option modules connected will result in Port 2 being configured to 175000bps, which is not supported for these modules. To configure Port 2 to a valid data rate connect to Port 1 and download a configuration with a valid data rate for Port 2.</p>
