PACSystems™ VersaMax

REMOTE IO MANAGER SOFTWARE RELEASE 2.04

Product: Remote IO Manager Software Release 2.04

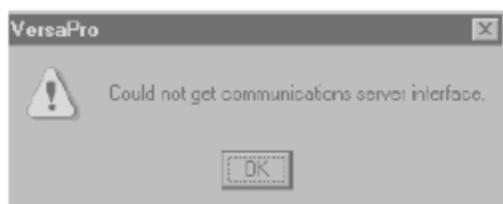
1. After installing VersaPro 2.0x and then subsequently installing VersaPro 1.0x or 1.1x, you may receive the following error during the installation process:

In addition, you may not be able to connect to PLCs after the installation completes and the following error message may appear.

Resolution:

A VersaPro 2.0x user wishing to install VersaPro 1.0x or VersaPro 1.1x can avoid this problem by following these steps:

- a. Uninstall VersaPro 2.0x: In the Windows Start menu, select Programs\Emerson Software\VersaPro\Uninstall. You can also open the Control Panel's Add/Remove Programs, then select "VersaPro 2.0x" for removal. (Uninstalling VersaPro 2.0x by letting the VersaPro 1.1x installer perform the uninstall should be avoided.)

- b. After the uninstall, shutdown and restart the computer.
- c. After the computer has started up, delete the "\Program Files\Common Files\Emerson\PLCServer" directory on the hard drive that contains the computers operating system. If you don't delete this directory and instead choose to delete all the files in the directory, you should make sure that the "Show All Files" option is selected under Folder options in Windows explorer. This is to ensure that all files including hidden files are deleted from the directory.

- d. Delete the following files from the directory \Windows (Win95/98) , \WinNT (NT4.0 Win2000, Win ME,Win XP):

- ccu_enu.dll
- egdservice.exe
- gefcl32.dll
- gefccu32.exe
- gefegd32.dll
- gefht32.dll
- gefsnp32.dll
- gefsrx32.dll
- geftcp32.dll
- hctpxyif.dll
- hdrvsnp.exe
- hdrvtcp.dll

- e. Install VersaPro 1.0x/1.1x
