PACSystems™ RX3i

RACKLESS ENERGY PACK - IC695ACC403

RACKLESS ENERGY PACK CABLE - IC695CBL003

RACKLESS RELACEMENT CAP PACK - IC695ACC413

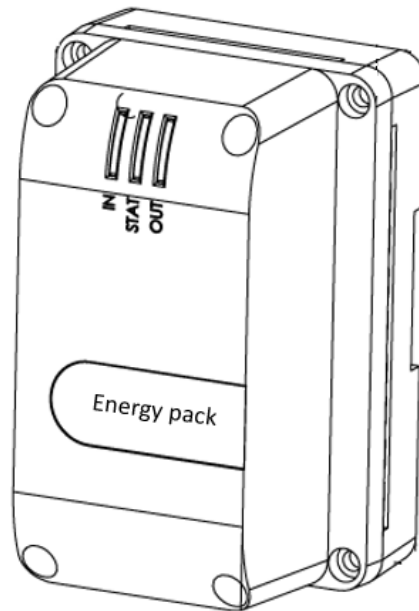
Whenever power is lost, the PACSystems™ RX3i IC695ACC403 Energy Pack provides the energy required for an orderly backup of user memory in the IC695CPE400 or IC695CPL410 CPU to which it is attached. IC695ACC403 consists of the Energy Pack base, a capacitor pack (Cap Pack), input power connector header, and a custom cable.
